# ANGUILLA SARGASSUM ADAPTIVE MANAGEMENT STRATEGY (SAMS)

## VOLUME 2: ACTION APPENDICES

DEPARTMENT OF  
NATURAL  
RESOURCES  
ANGUILLA

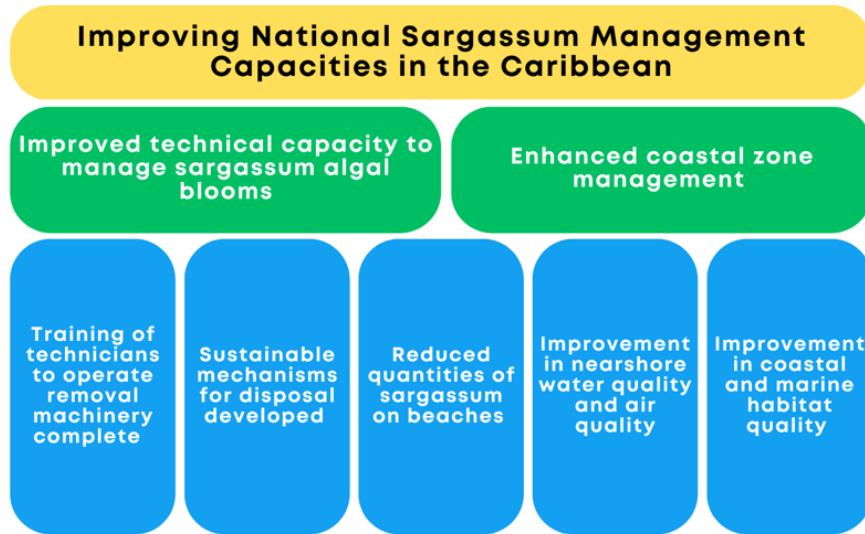
Over the years various collection techniques were tried and tested, with many lessons learned, as highlighted in the various guidance documents presented in the previous section. A systems approach is essential for improving national capacities for sargassum management. It is assumed that if mechanisms to support the effective and continuous collection of sargassum seaweed are implemented, and the technical capacity for sargassum removal is increased, then the resilience of coastal areas will be improved<sup>4</sup>. The figure below illustrates further.

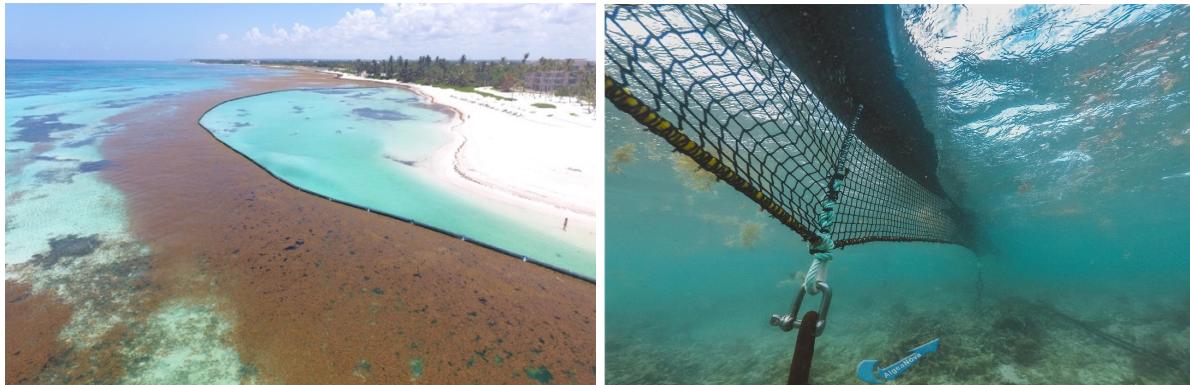
Offshore barriers work either through diversion away from sensitive areas or through storage and containment.

Source: Algeanova- Offshore barriers designed and deployed by Algeanova in the Dominican republic.
